Geomorphological mapping and geophysical profiling for the evaluation of natural hazards in an alpine catchment

A. C. Seijmonsbergen, L. W. S. de Graaff

A. C. Seijmonsbergen, L. W. S. de Graaff. Geomorphological mapping and geophysical profiling for the evaluation of natural hazards in an alpine catchment. *Natural Hazards and Earth System Sciences*, 2006, 6 (2), pp.185-193. hal-00301642

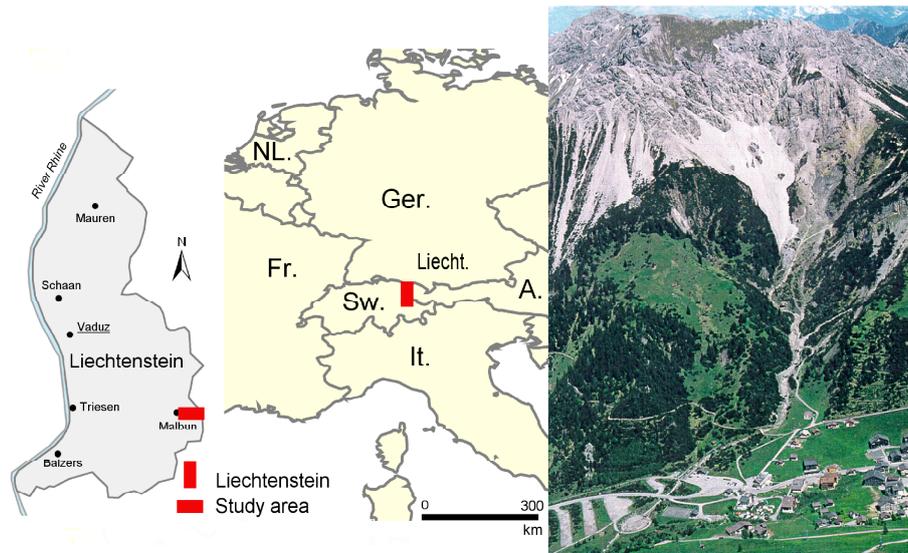
Fig. 1. Location of the study area. The photo shows the small “Schlucher” catchment.

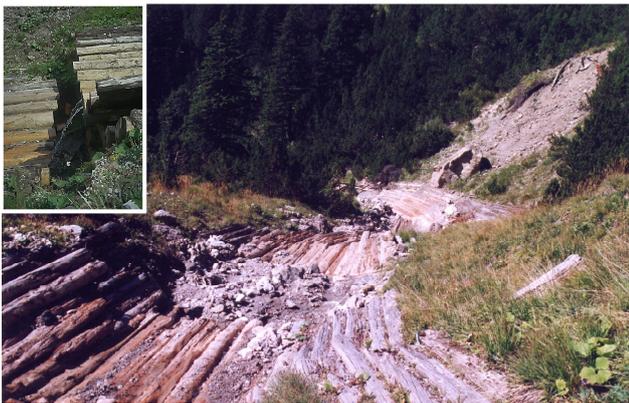
Fig. 2. The wooden drainage system is disrupted by the eroding power of debris flows, by small slides from the adjacent slopes (top right) and by differential movements within the landslide (detail top left), which leads to increased displacements rates.

displacements within the landslide and the erosive forces of debris flows (Fig. 2). The resulting infiltration increased the displacement rates. It was noticed by Wenzel (1985) that the landslide could pose a serious threat to Malbun; in the event of a sudden failure over 500 000 m³ of material could be released. We therefore decided to evaluate the landslides and especially the displacement *pattern and depth* of the landslide in the central part of the catchment (see Fig. 3). The objectives of the study were: 1. to prepare a detailed 1:3000 geomorphological map that shows the spatial distribution of all landforms and processes; 2. to carry out a geophysical analysis over the gypsum underlain landslide, and 3. to present a GIS-supported hazard zonation of debris flows.

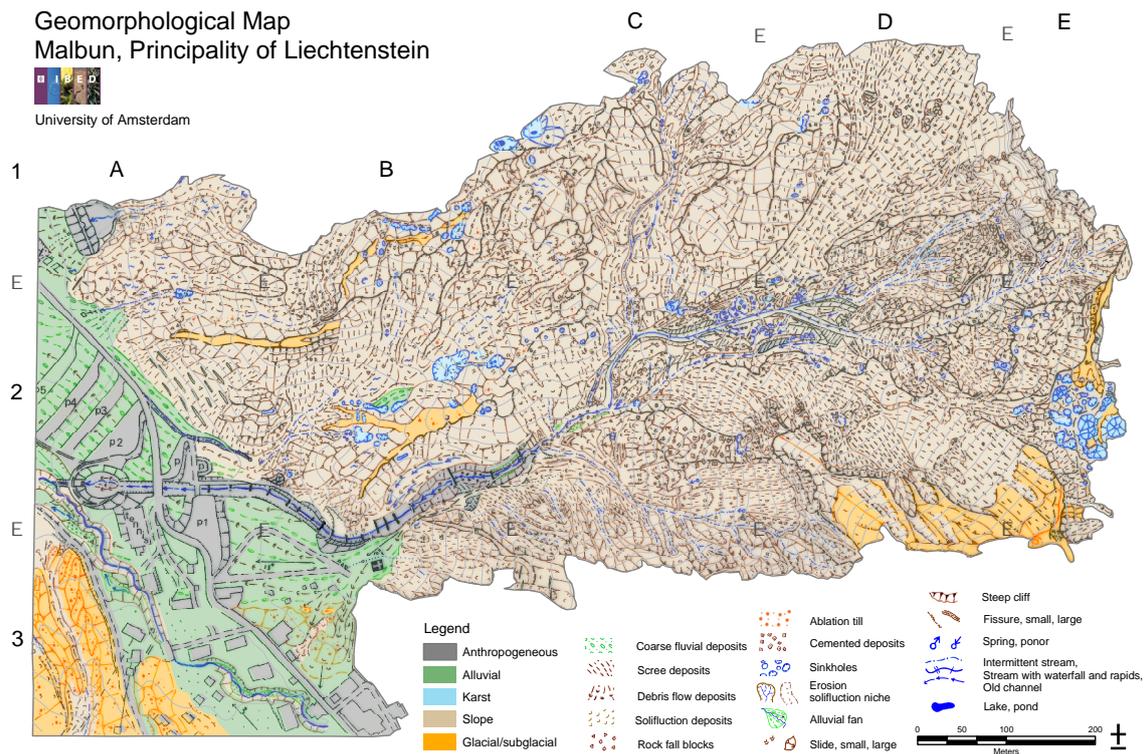
**Fig. 3.** Geomorphological map Malbun, Principality of Liechtenstein.

The geomorphological map of the Schlucher catchment (Fig. 3) shows landforms and processes at the 1:3000 scale. The legend is a modified version of the legend developed for alpine areas by de Graaff et al. (1987) and Seijmonsbergen (1992). The scale of the map ensures that most geomorphological features are represented without generalizations. For ease of reference the map is divided into squares A1–E3 with A1 in the NW and E3 in the SE corner (Fig. 3).

The area is dominated by both surface and deep seated mass movement. Therefore, few relicts of glacial landforms and deposits have been preserved. Only local ridges between some sub-catchments (e.g. in square B2) and a series of moraine ridges in A3 have been preserved. These ridges document a late-glacial blockage of the Schlucher catchment by the larger Malbun glacier. This blockage caused a local rise of the erosion base. This resulted in the accumulation of

The presence of gypsum and anhydrite leads to collapse karst and naked karst landforms. In a runoff and debris flow channel in square C2 a collapse depression was formed in 1999 (Fig. 3). These collapse depressions can substantially decrease the impact of debris flows, because they serve as debris traps and, therefore, reduce mass and momentum. An example of naked karst in sub-horizontal terrain is shown e.g. at the local water divide in square B1. Some of these sinkholes are elongated and aligned, and this suggests that they are related to faults or thrust zones in the Raibler Formation.

The location and relations between processes, material and form are derived from the geomorphological map (Fig. 3). The source area of the debris flow deposits are shown in the process attribute map (Fig. 6), which suggests that debris

flows may still reach parts of Malbun village. The occurrence of surface collapse dolines, in active debris flow tracks, is evidence that these features may hamper sediment transport by debris flows. The two geo-electrical profiles showed similar resistivity patterns; hence, only one profile is given (Fig. 5). The location of the geo-electrical profile is shown in Fig. 6. A three layer model is proposed. Low values on the landslide are recorded to a depth of approximately 20 m. An undulating boundary shows the transition to high resistivity values. The low values correspond to the disintegrating materials of the landslide, which are derived from the Arosa Zone, and mainly from the Raibler Formation (anhydrite and gypsum). The high values are characteristic for in situ bedrock values. The surrounding geomorphology, in which sink holes and collapse dolines are common features, strongly suggests that the undulating boundary is influenced by karst. The higher surface resistivity values near and upslope from point 192 m coincide with a cover of debris flow material composed of coarse dolomite rock fragments on top of the landslide. These boundaries match the surface distribution of the debris flows as shown in Fig. 3.

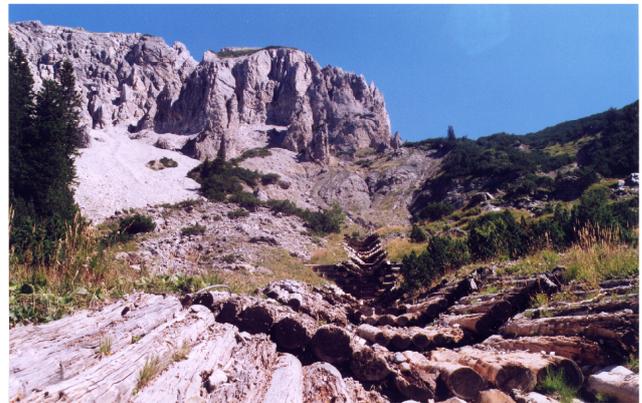
Fig. 4. Upslope view with the steep Hauptdolomite cliffs and associated scree slopes in the upper left part. The central part of the photo shows the major scarp of the gypsum underlain landslide. In the foreground the eroded drainage system is shown.

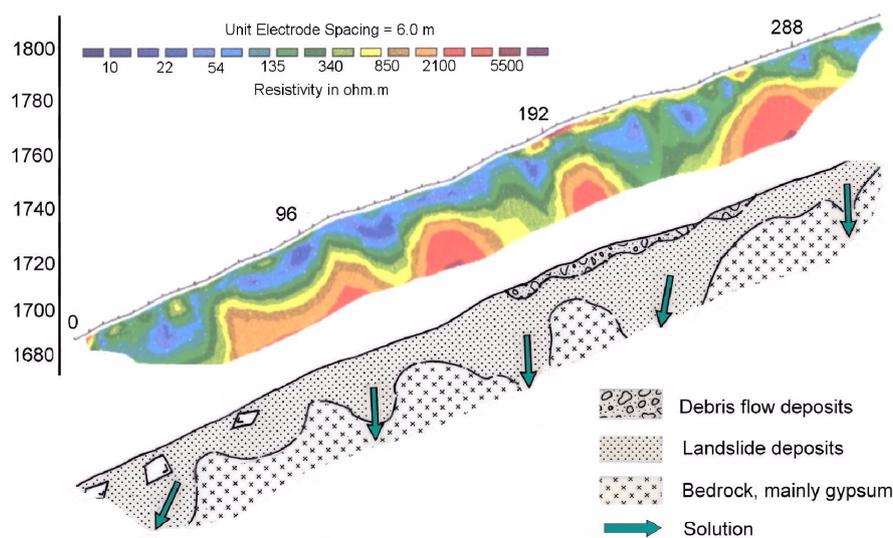
Fig. 5. Top: subsurface resistivity profile along the central landslide, for profile location see Fig. 7. The lower part shows a three layer geological interpretation of the resistivity profile.

The gypsum underlain landslide in the central part of the catchment was investigated in more detail. In 1983 a system of benchmarks was installed on and around the lower part of the central landslide. Since 1985 the horizontal and vertical displacements are recorded by the “Landesamt Für Wald, Natur und Landschaft in Vaduz (de Graaff and Seijmonsbergen, 2000¹). In total 26 benchmarks were digitised and their yearly movement rates were recorded in point attribute tables. Fifteen benchmarks are located on the landslide of interest. In Fig. 6 the interpolated total horizontal displacement is shown. In ArcGIS the outline of the central landslide acted as a boundary mask for inverse distance weighting interpolation within the landslide. Two geo-electrical profiles with a length of respectively 330 m and 246 m were constructed over the crown of the landslide using a Sting-Swift earth resistivity meter. The aim of the geophysical profiling was to determine the depth of failure and to better understand the nature of the displacements. The distance between each of the 28 electrodes was 6 m, which allowed a penetration depth of 20–30 m. The resistivity values depend on the conductivity characteristics of the subsurface materials. Non-weathered bedrock has a relatively high resistivity, whereas disrupted anhydrite and gypsum rocks appeared to have low resistivity.

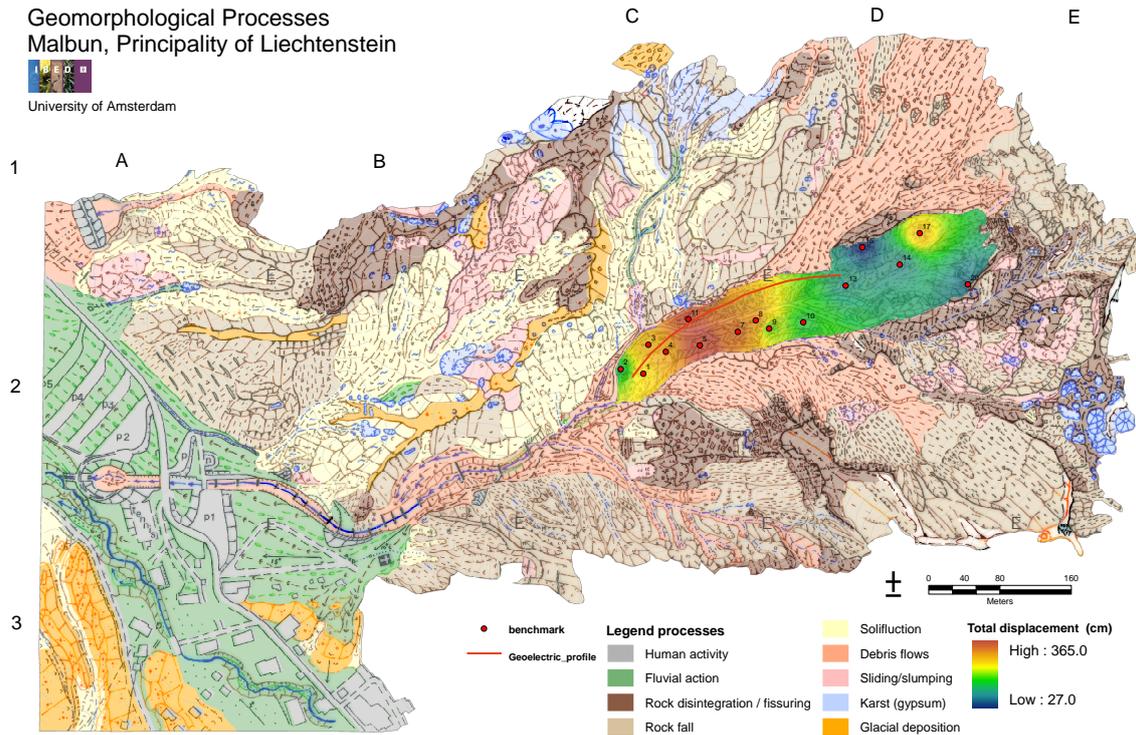
Fig. 6. Geomorphological processes Malbun, Principality of Liechtenstein.

In the central part of the Schlucher catchment a landslide underlain by gypsum is present (Wenzel, 1985). The outline of the central landslide is shown in Fig. 6. The back scar is located between 1850 and 1920 m, the side scars reach downslope to approximately 1800 m and expose heavily tectonized gypsum and anhydrite layers (Fig. 4). The lower end of the landslide is now situated at 1700 m altitude, which suggests a minimum displacement of 150 m. Rapid mass movements occur along the steep upper surrounding cliffs. Rock- and scree fall produces vast amounts of scree slopes which serve as source areas for debris flows, e.g. in square D1 (Fig. 3).

In Fig. 6 the total displacements values over 15 years within the landslide indicate that the largest displacements occurred near the frontal section of the landslide. Benchmarks 5 and 11 have a vertical displacement of more than 3 m. This is related to local steeper slope gradients, which favours the development of tension cracks and sliding. This pattern can be attributed to fragmentation of the frontal slide masses into smaller slide units. After failure, these slides are too small to pose a serious threat to Malbun village. Benchmark no. 17 is located on an individual rock fall block that has moved down slope, resulting in a local optimum in the displacement rate.

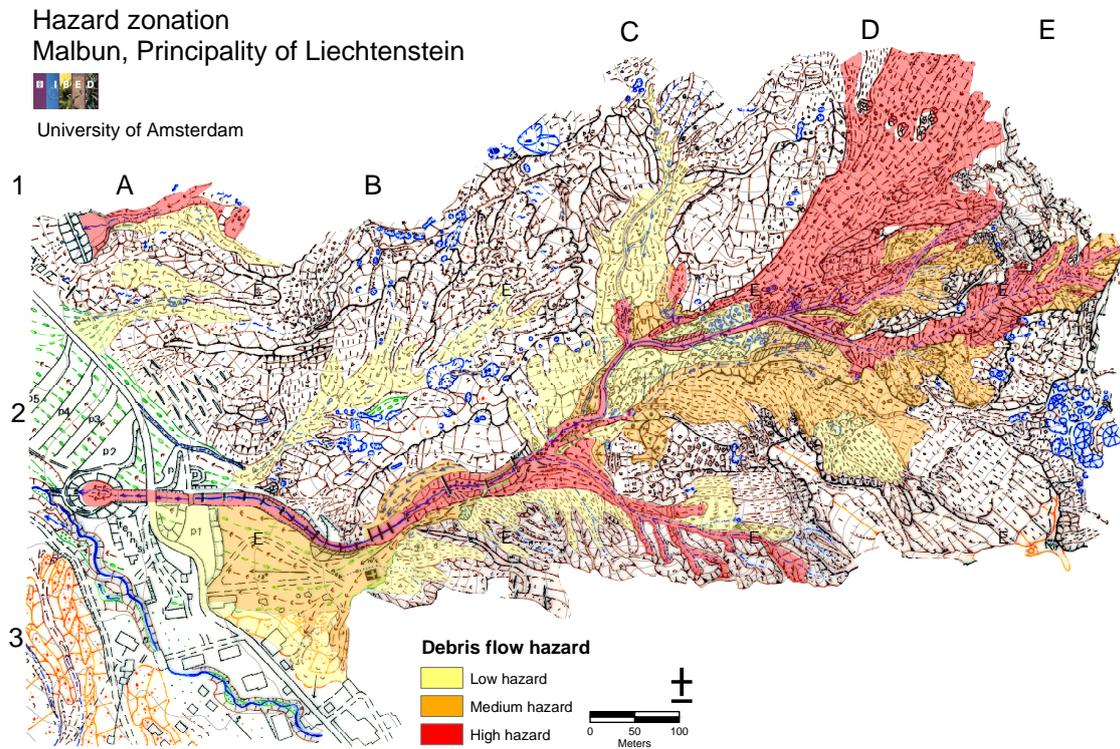
Fig. 7. Hazard zonation Malbun, Principality of Liechtenstein.

The hazard zonation map (Fig. 7) is prepared by selecting those areas from the attribute table that are related to the actual process of debris flows and to those areas underlain by inactive debris flow source materials and deposits. In the field we noticed from local exposures that areas underlain by thick solifluction deposits often contain debris flow deposits. For this reason, areas underlain by solifluction deposits were also selected to define the hazard zone. The degree of hazard used is: low, medium or high. High activity refers to areas with current debris flow activity. These areas can easily be distinguished from the ortho-photo because of their high reflectance, absence of vegetation and the non-weathered debris fragments in the field. Medium activity refers to areas showing distinct vegetation growth (grass, low shrubs), and a slightly raised position in the terrain. Low activity was assigned to all other debris flow deposits and solifluction areas. The latter may act as debris generating areas in the Schlucher catchment. In practice, minor manual additions and/or changes of the hazard zonation were made by the expert during the process of preparation of the hazard zonation map.

The hazard zonation map (Fig. 7) shows all areas that are potentially exposed to debris flows. The largest source area for active debris flows is in D1. Debris may travel north along the central landslide through the wooden channels; in a worst case scenario they may cover the debris fan in A/B2/3.
