Advanced Characterization Techniques for SiC and PyC Coatings on High-Temperature Reactor Fuel Particles

Advanced characterization techniques for SiC and PyC coatings on high-temperature reactor fuel particles

Abstract

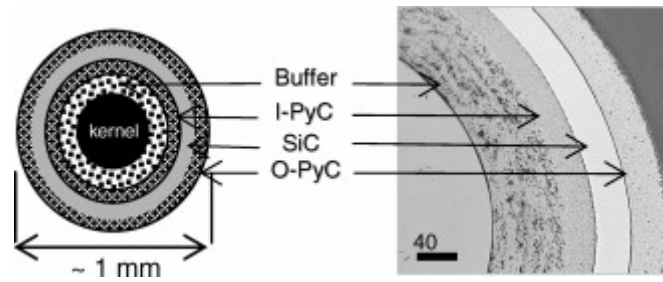
Fig. 1. Particle cross-section showing the kernel, the buffer, the inner PyC (I-PyC), the SiC and the outer PyC (O-PyC).

Fuel particles are produced by a fluidized bed Chemical Vapor Deposition (CVD) process according to the original technique conserved, enhanced and currently investigated by the CEA in Grenoble using simulated coated particles with ZrO_2 - Y_2O_3 kernels and a three fluidized bed furnace. A typical coated particle cross-section is shown in Fig. 1. The kernel is coated by a low density pyrocarbon layer (buffer) and three successive dense layers: an inner dense pyrocarbon layer (I-PyC), a silicon carbide (SiC) layer and an outer dense pyrocarbon layer (O-PyC).

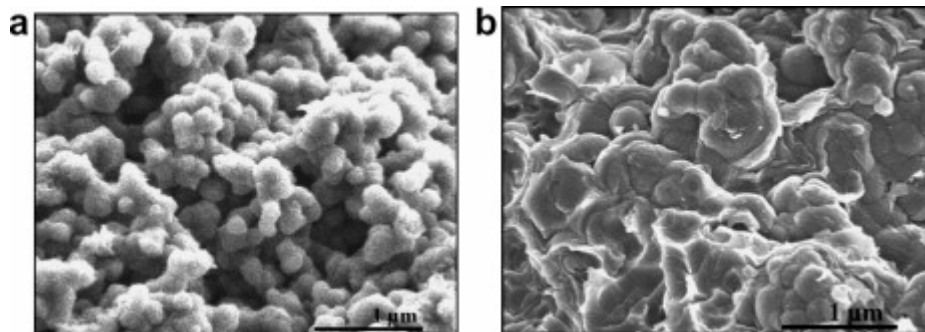
Fig. 2. Fracture surfaces observed by SEM of (a) the buffer and (b) the dense I-PyC.

The buffer and dense PyC texture observed by SEM on fracture surfaces is shown in Fig. 2. The buffer is constituted by concentric growth features (spheroids) 300–400 nm in diameter (Fig. 2(a)). A heterogeneous distribution of large cavities is evidenced. Dense PyC is composed of agglomerated spheroids (Fig. 2(b)) about 400 nm in diameter, typical of reactions in the gas phase (homogeneous growth) [5]. On the fracture surfaces, PyC deposited directly on the surface (heterogeneous growth), can also be distinguished between the agglomerates (Fig. 2(b)).

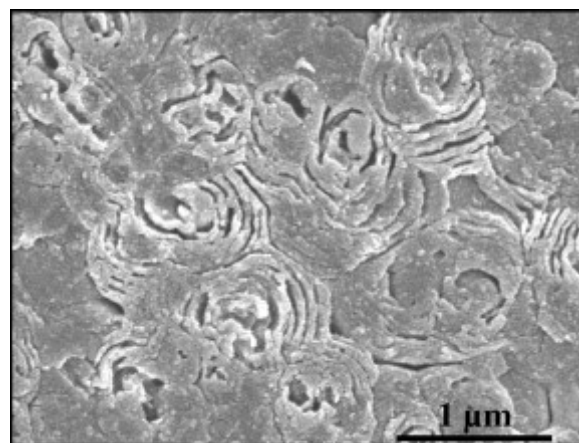
Fig. 3. Polished and etched cross-section of the dense I-PyC observed by SEM.

Murakami chemical etching evidences the main features of the PyC microstructures. The texture of carbon spheroids is clearly visible on a polished and etched cross-section of dense PyC (Fig. 3). They exhibit an onion-like texture with concentric carbon layers. Etching occurs preferentially in regions corresponding to direct PyC coating on the surface. In these regions, the deposit is not concentric (anisotropic fraction or 'layered' carbon).

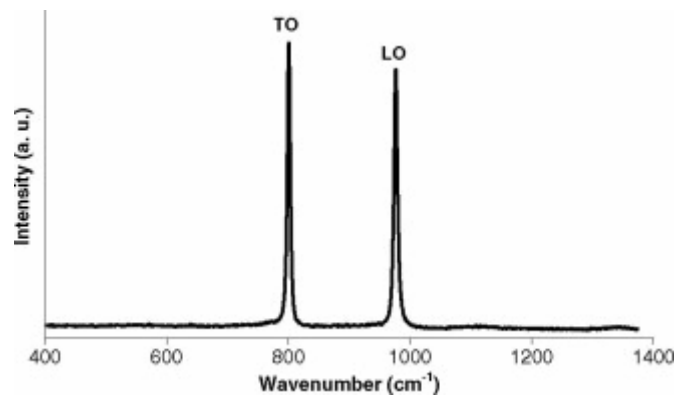
Fig. 10. First-order Raman spectrum obtained on SiC cross-section.

HR-TEM observations show that regular hexagonal faulted structures (polytype with large period) are not abundant. It is more common to find some random stacking faults which correspond to one-dimensionally disordered polytype [12]. In this case, diffuse streaking of lesser intensity appears in the (1 1 1) directions on the corresponding SAED diagram. The fact that hexagonal polytypes (α -SiC) are not abundant is confirmed by X-ray diffraction (XRD) (Fig. 5) and Raman microspectrometry analysis (Fig. 10). The α phase was never detected with either technique. Raman spectra show two sharp peaks at 797 cm^{-1} (transverse optic: TO) and 976 cm^{-1} (longitudinal optic: LO), typical of the 3C polytype. The fact that there is no evidence of any secondary phase contradicts earlier results [13] reporting a small fraction of α -SiC measured by XRD, although the processing conditions were not exactly the same.

As already noted, all the deposits characterized by Raman microspectrometry consist exclusively of β -SiC. Raman spectra also demonstrate that there is no excess carbon and
