# Advanced Characterization Techniques for SiC and PyC Coatings on High-Temperature Reactor Fuel Particles

D. Helary, O. Dugne, Xavier Bourrat

D. Helary, O. Dugne, Xavier Bourrat. Advanced Characterization Techniques for SiC and PyC Coatings on High-Temperature Reactor Fuel Particles. *Journal of Nuclear Materials*, Elsevier, 2008, 373 (1-3), pp.150-156. 10.1016/j.jnucmat.2007.05.041 . insu-00159978

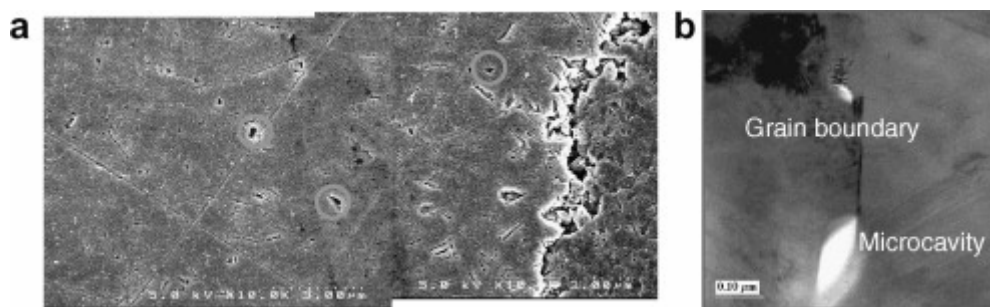
Fig. 12. (a) SEM micrograph of SiC etched for 10 min. Polished section perpendicular to the plane of deposition. (b) TEM micrograph of SiC.

SEM observations of fracture surfaces and external cap show no apparent pores. It would thus appear that there is no crack initiator in the SiC deposit. This feature was checked by using a short etching procedure which revealed some potential cracks: microcavities are present in the area close to the SiC/I-PyC interface (rings in Fig. 12(a)). These microcavities are also detected by TEM examinations (Fig. 12(b)). When the internal gas pressure increases, a tensile hook stress can develop in the SiC layer, flaws can then propagate and generate radial cracks in the SiC deposit.

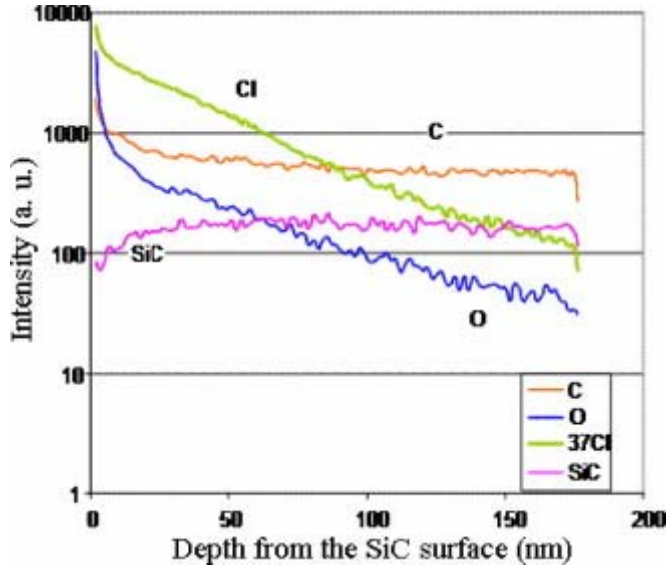
Fig. 13. Depth profile of <sup>37</sup>Cl, Si, O, C in the SiC surface.

Chlorine, which may be a residue of the  $\text{CH}_3\text{SiCl}_3$  gas precursor, was analyzed by electron probe microanalysis (EPMA) on cross sections. Under irradiation, the stable isotope  $^{37}\text{Cl}$  becomes radioactive (as  $^{36}\text{Cl}$ ), so it is of great importance that the deposit contains no chlorine to prevent the release of radioactivity into the environment. The results indicate that it is present in only very small amounts, its concentration is always less than 15 ppm. Additional data are obtained by depth profiles recorded by static secondary ion mass spectrometry (SSIMS). Chlorine is more abundant at the extreme surface but its depth-concentration decreases very rapidly (Fig. 13).
