## Modelling and back-analysing failures in steep limestone cliffs

Magali Frayssines, Didier Hantz

Magali Frayssines, Didier Hantz. Modelling and back-analysing failures in steep limestone cliffs. *International Journal of Rock Mechanics and Mining Sciences*, 2009, 46 (7), pp.1115-1123. 10.1016/j.ijrmms.2009.06.003 . insu-00498736

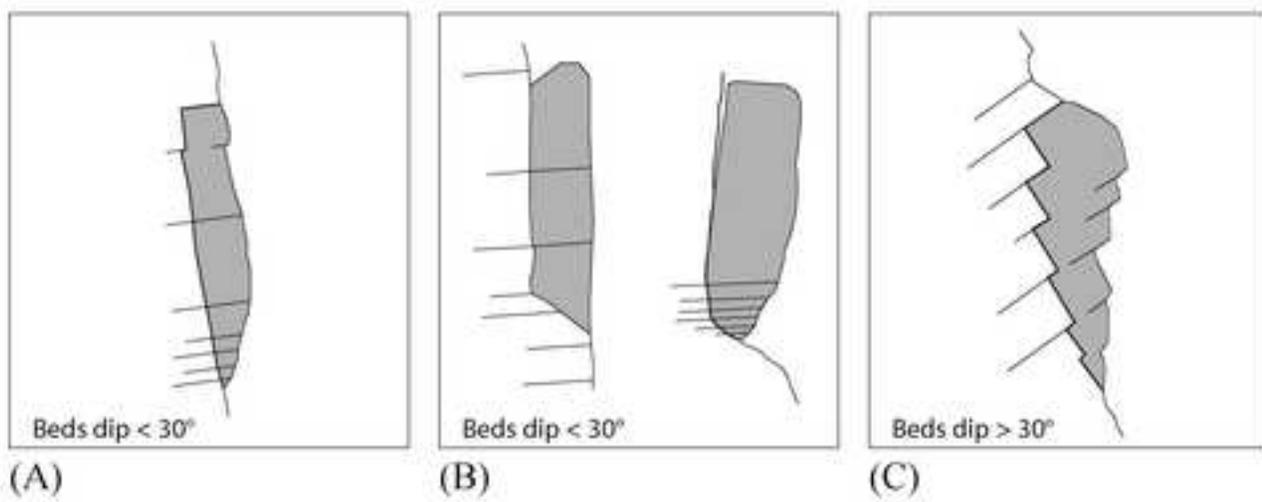
Fig. 1. Typical failure configurations in steep limestone cliffs, with beds dipping less than  $30^\circ$  (A and B) or more than  $30^\circ$  (C)

Figure 1 shows 3 typical failure configurations observed between the surveyed 25 rock fall events. Where the beds dip less than 30°, A and B failure configurations have been observed. In the first one (A), the unstable rock mass rests on a steep joint plane, which is roughly perpendicular to the bedding (cross-joint), on which sliding is possible in a translational mode. Toppling is also possible depending on the size of the overhang. In the second configuration (B), the cross-joint is not sufficient to constitute a failure surface and another joint (less inclined and generally shorter than cross-joints) makes up the low bound of the unstable block, on which sliding is possible. Sliding may occur on this singular joint in a translational mode (with opening of the cross-joint) or in a more complex mode (compound slide). Toppling requires opening of both joints. Where the beds dip more than

30° opposite the slope, the C configuration has been observed. The main joint set is perpendicular to the bedding and it defines a potential sliding surface. This failure surface is stepped where the bedding planes form overhangs. For the two first configurations, it is often difficult to know which of the two mechanisms will occur: sliding or toppling, if no precise cliff topographical model is available. In this case, both sliding and toppling must be considered in the analysis.

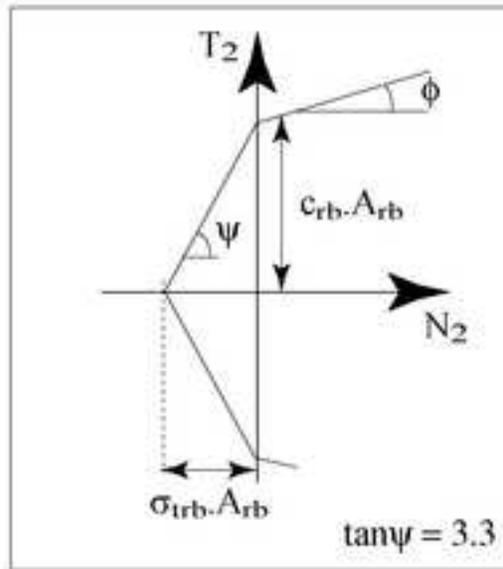
Figure 3  
[Click here to download high resolution image](#)

Fig. 3. Failure criterion for a normal tensile force.  $N_2$  and  $T_2$ : normal and tangential forces.  $c_{rb}$  and  $\sigma_{trb}$ : cohesion and tensile strength.  $A_{rb}$ : rock bridge surface.  $\psi$ : tensile friction angle.  $\Phi$ : friction angle.

Where  $A_{rb2}$  is the total area of the rock bridges on the plane 2 and  $\tan \psi$  is the ratio between the cohesion and the tensile strength of the rock bridge (Fig. 3).

The failure criterion for the rock bridge is given by equation (9) and shown in Figure 3. This hyperstatic problem has 5 unknowns ( $N_1$ ,  $T_1$ ,  $R_2$ ,  $\delta$ ,  $C_{rb}$ ) and 4 equations (Eq. 22 to 25). The angle  $\delta$  was determined using the maximum work principle in order to calculate the resisting force in a rock bolt [22]. This principle is illustrated in Fig. 12. In a normal versus shear force diagram, the end of the resisting force  $R_2$  on rock bridge, must be located on the failure criterion, in such a way that the scalar product of the displacement vector  $\vec{u}$  and the opposite of force  $R_2$  is maximum (the opposite of  $R_2$  is the force exerted by the moving mass, on the stable rock mass). Introducing Eq. (26) and (27) into Eq. (25), the cohesion of the rock bridge is:

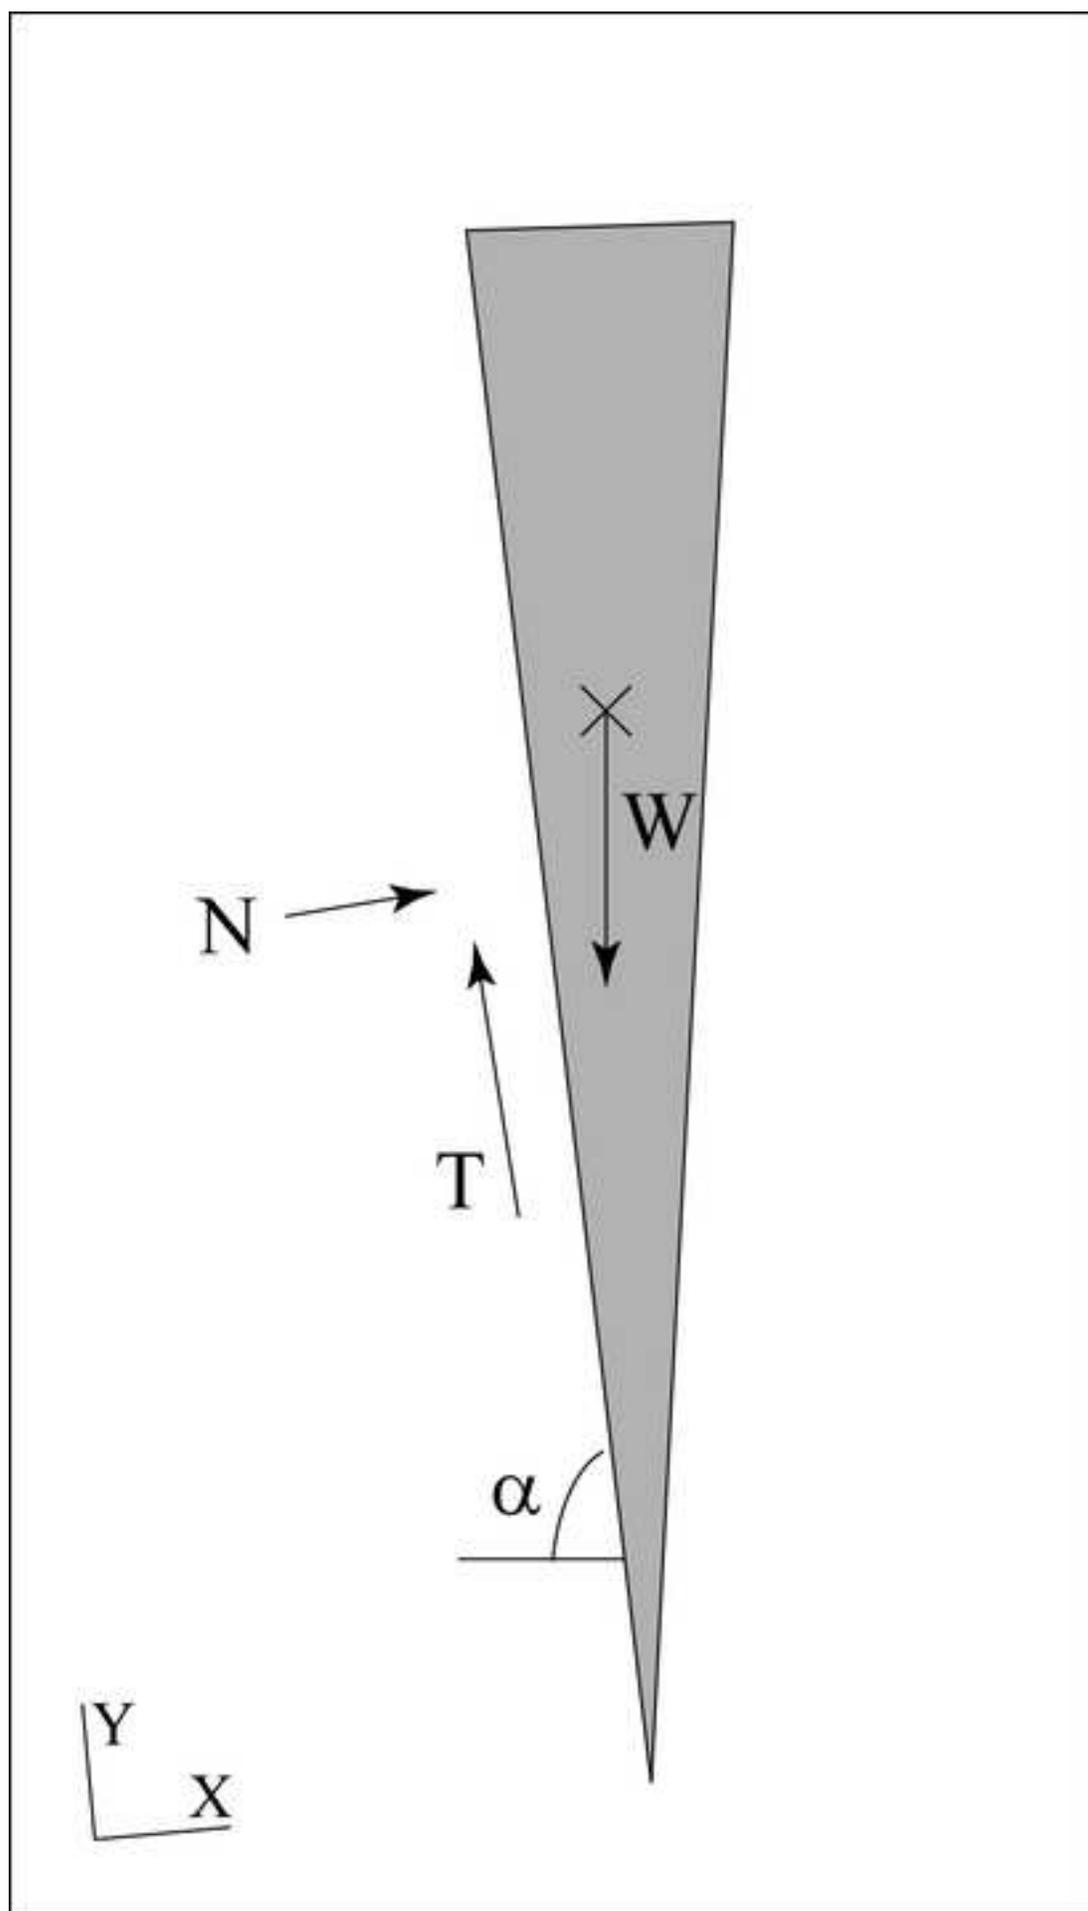
Figure 4  
[Click here to download high resolution image](#)

Figure 4 shows the method of analysis applied for the isostatic condition modelling. The resisting force required for equilibrium, is determined by the equilibrium equations. Different values for the mechanical parameters of the rock bridges and the joints can give this resisting force. We considered that the friction angles were given by the laboratory tests and we determined the rock bridge cohesion which gave the required resisting force. By using the limit equilibrium method in the  $X$  and  $Y$  directions, equations 1 and 2 are obtained:

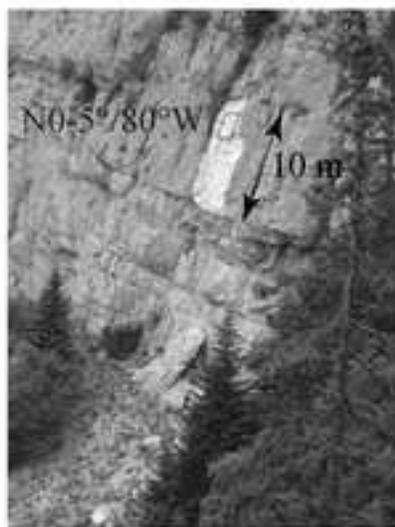
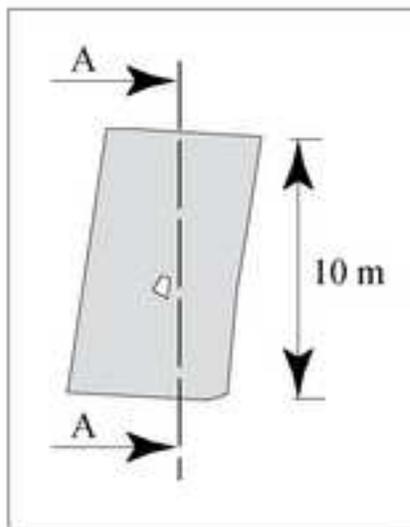
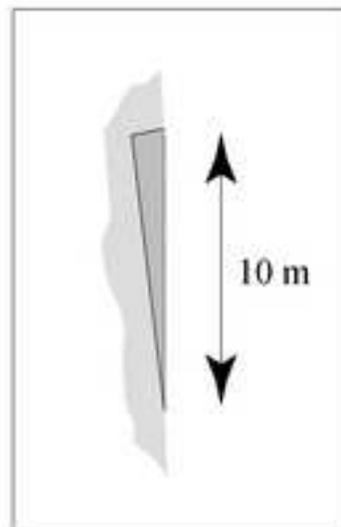
Figure 5  
[Click here to download high resolution image](#)

Fig. 5. (A) Scar of the Pas du Fouillet rock slide, (B) sketch of the scar with the rock bridge (white) and (C) cross-section A-A before failure

part of a 200 m high urgonian limestone cliff striking N10° and dipping 85° to the West. Two major joint sets N10°/81°W (J1) and N114°/81°SW (J2) cut sub-horizontal limestone beds. The sliding plane is about 10 m high and 4 m wide and it is made up of a joint N0-5°/80°W belonging to the J1 set (Fig. 5). It is bounded to the North by a joint N110°/90° belonging to the J2 set, which opened when sliding occurred. A fresh fracture surface with an area of 0.08 m<sup>2</sup> is due to a rock bridge fracture (Fig. 5B). The cohesion of the rock bridge as determined by back analysis is 6.6 MPa.

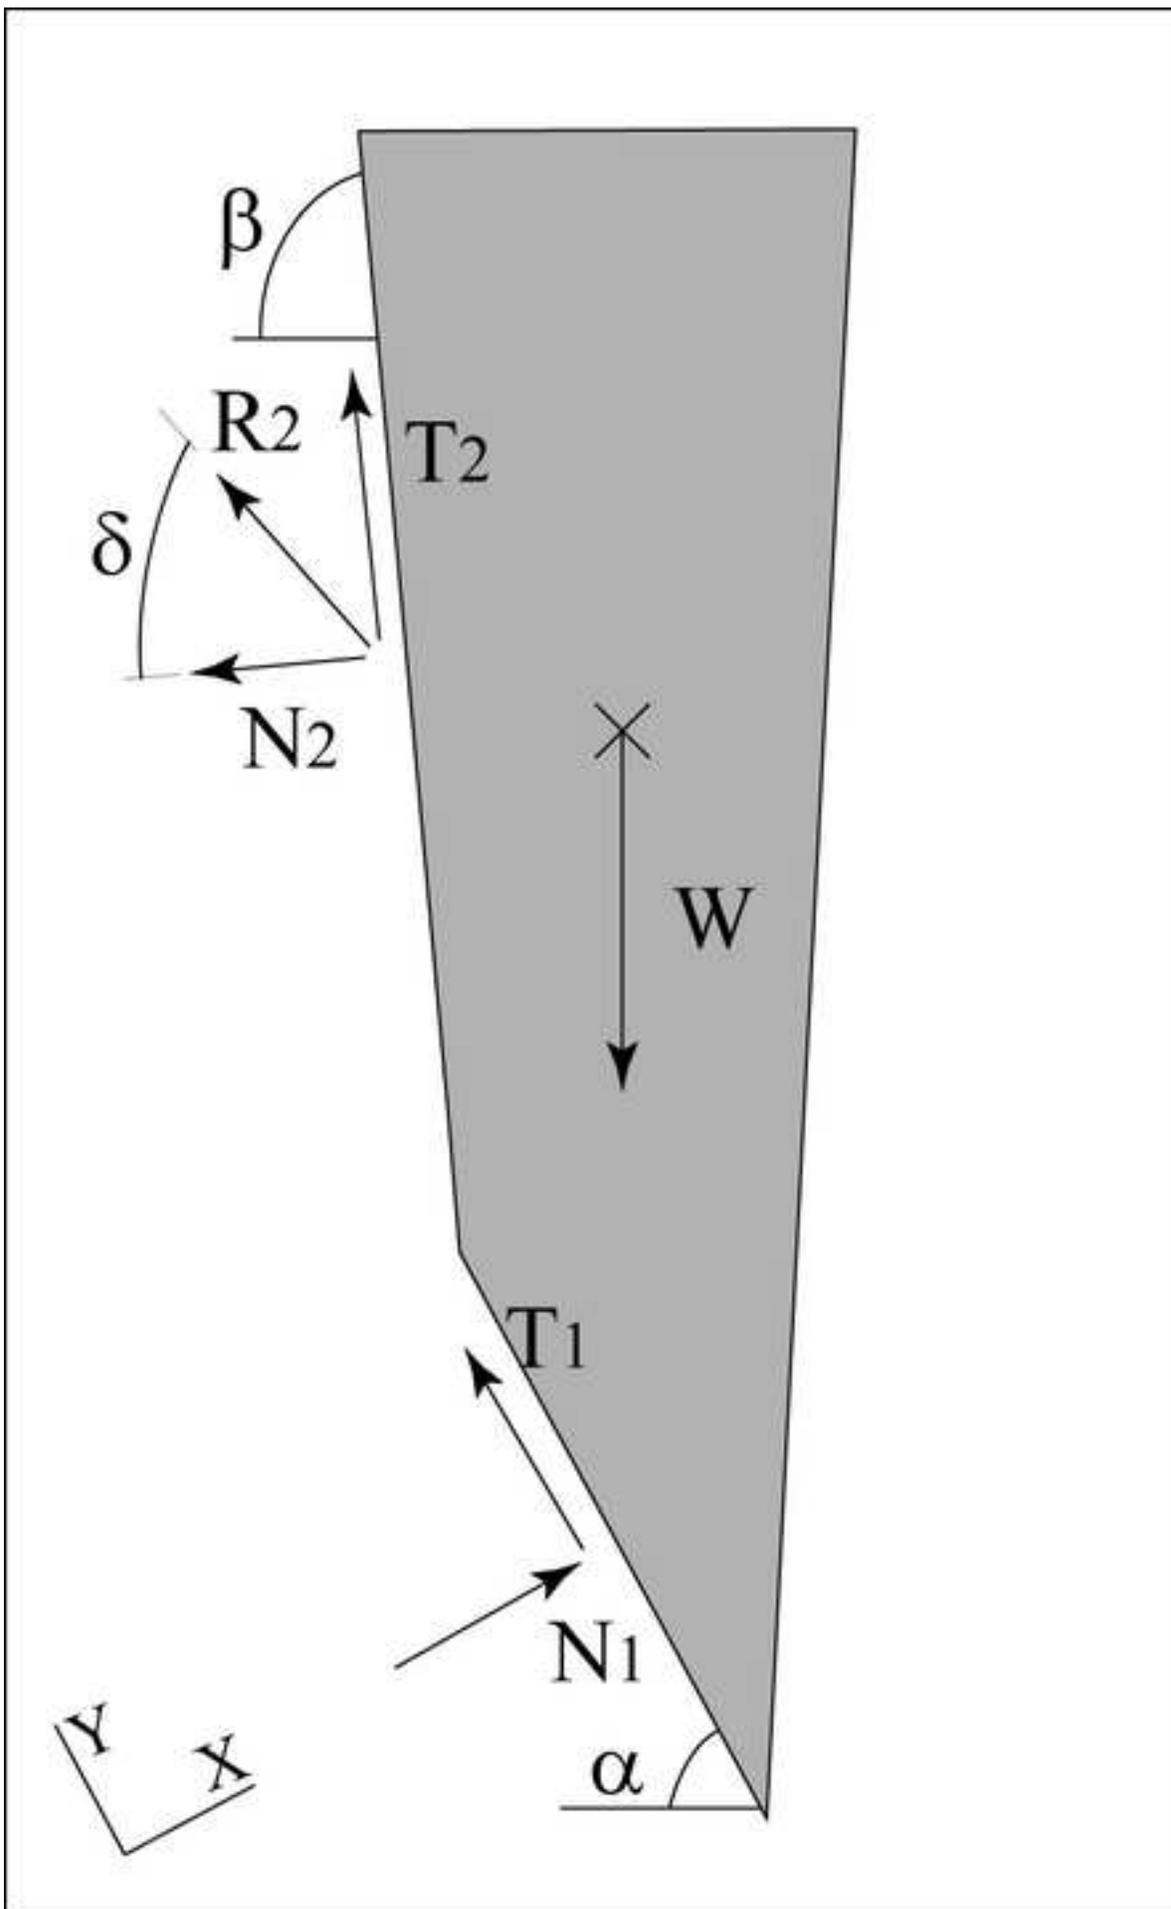
Figure 6  
[Click here to download high resolution image](#)

Figure 6 shows the method of analysis applied for the hyperstatic conditions modelling. By using the limit equilibrium method in the *X* and *Y* directions, equations 5 and 6 are obtained:

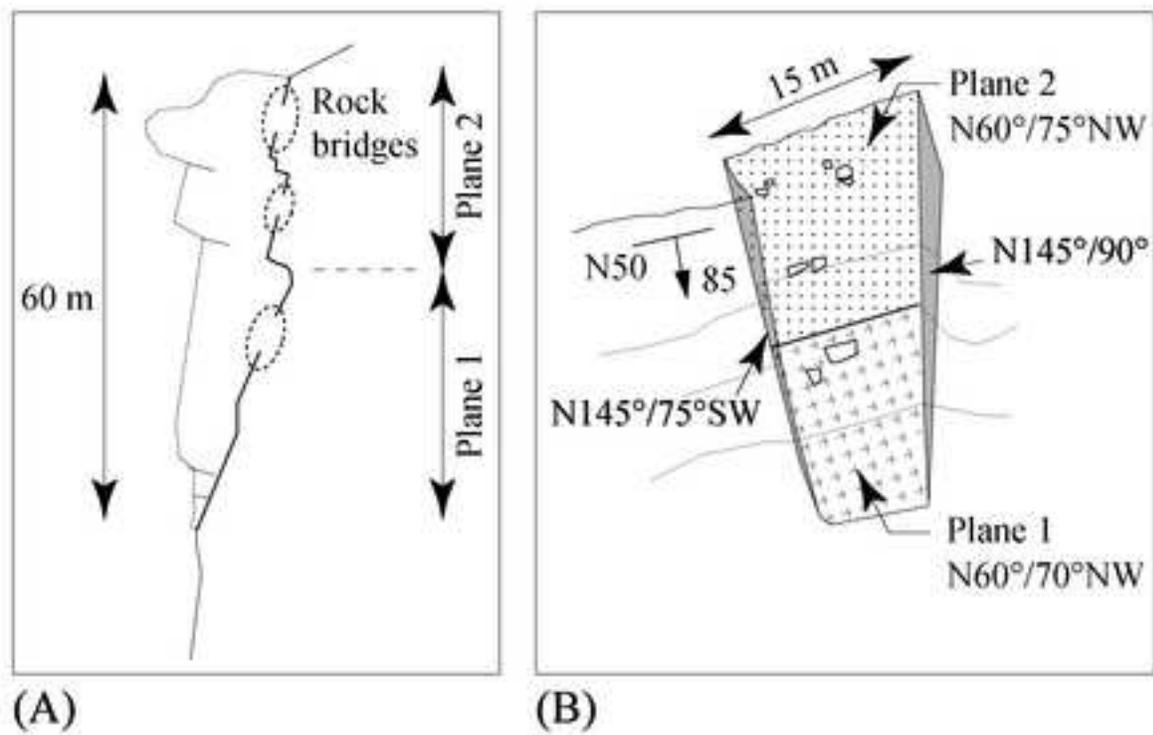
Figure 7  
[Click here to download high resolution image](#)

The Dent du Loup rock fall, with a volume of 6000 m<sup>3</sup>, occurred during the night of 4th January 2001, in the Vercors massif, 8 km North-West of the town of Grenoble (Fig. 2). The major part of the fragmented rock mass stopped near the toe of the cliff, destroying 0.5 hm<sup>2</sup> of wood. One block stopped 150 m from houses located in the valley. The rock fall broke away from the top of a 180 m high limestone cliff striking N50° and dipping 85-90° to the north-west. The scar is roughly 60 m high and 15 m wide. From analysis of aerial photographs, four main subvertical joint sets were detected: N0° (J1), N50-70° (J2), N80-100° (J3) and N140-160° (J4). In the scar, bedding planes (N0°/30°E) form several overhangs (Fig. 7A). The failure surface is made up of bedding planes, a main irregular sliding surface N60/70-85°NW which belongs to joint set (J2) and two lateral planes in the upper part of the scar: N145°/75°SW (on the North-East side) and N145°/90° (on the South-West side), belonging to the joint set (J4) (Fig. 7B). The main sliding surface can be approximated by two planes: a lower plane (1) dipping 70° and an upper plane (2) dipping 75° (Fig. 7). According to the block theory [20], the failure mechanism was a wedge slide on the two planes N60/70°NW and N145°/75°SW. However, the normal stress was mainly applied on the plane N60/70°NW and there was no cohesion on the lateral plane N145°/75°SW (no fresh fracture). Thus the resisting force on the lateral plane was neglected and a planar slide was assumed on the plane N60/70°NW. Fresh fracture surfaces cover 4.7m<sup>2</sup> on the plane 1 and 4.3 m<sup>2</sup> on the plane 2. The total scar area was 1000m<sup>2</sup>. The cohesion of the rock bridges determined by back analysis was 12.4 MPa.

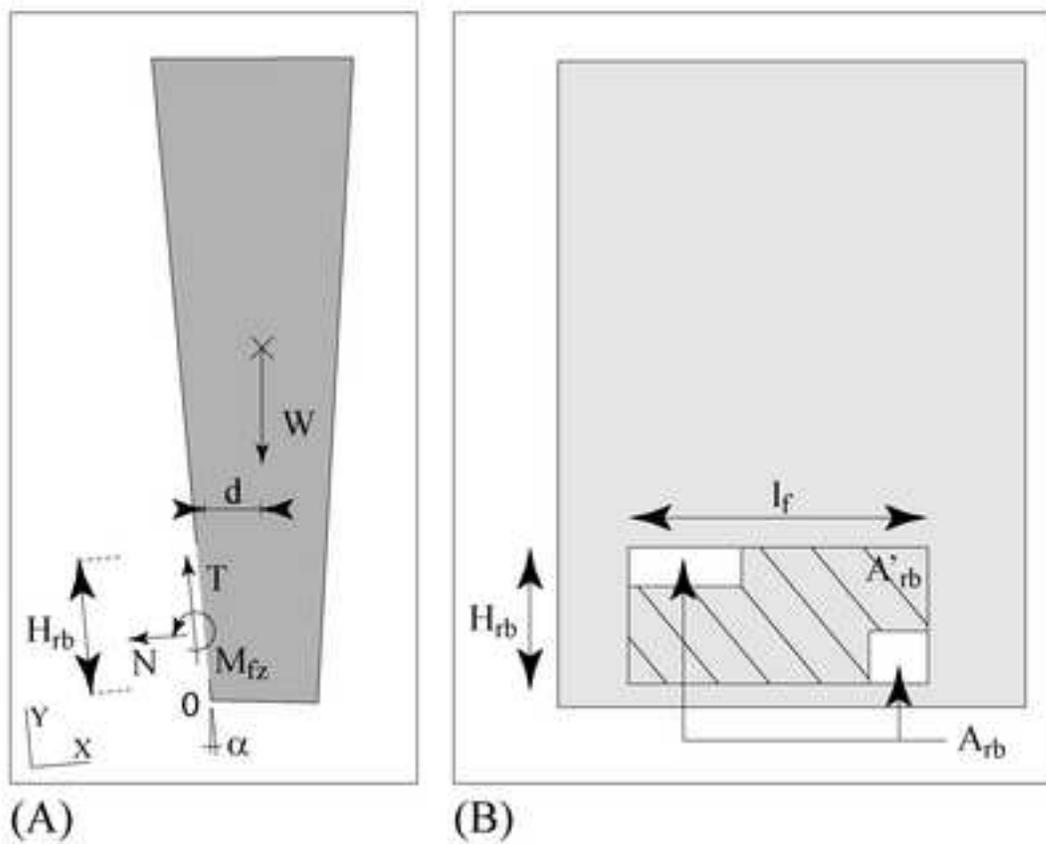
Figure 8  
[Click here to download high resolution image](#)

In the observed cases of isostatic toppling, the rock bridges were concentrated in the lower part of the scar. In the model the zone where the rock bridges are concentrated, was considered as a unique equivalent rock bridge, with equivalent strength properties (Fig. 8B).

Figure 8A shows the equilibrium conditions of forces and moments described by equations (13 - 15):

Where  $H_{rb}$  is the height of the equivalent rock bridge (Fig. 8) and  $l_f$  is the width of the failure surface (Fig. 8).

Where  $A_{rb}$  is the total area of the actual rock bridges (Fig. 8B) and  $A'_{rb}$  is the area of the equivalent rock bridge (Fig. 8B).

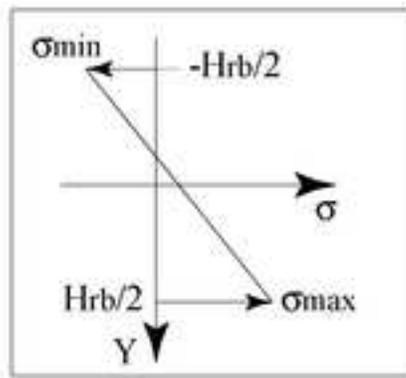
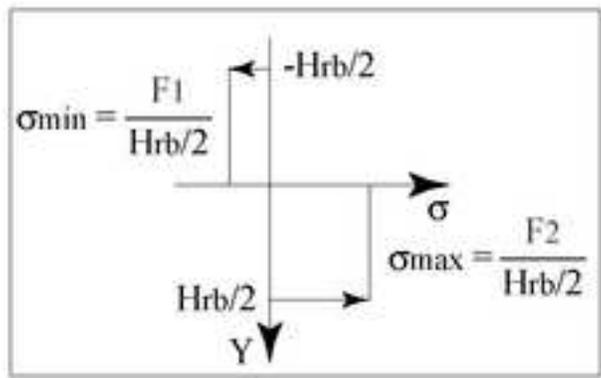
Figure 9

Note that for design purposes, the hypothesis of a linear distribution of the normal stress (Fig. 9A) is more conservative (or more pessimistic) than the hypothesis of a rectangular distribution (Fig. 9B), which is adopted, for example, in the UDEC code [21]. For the second hypothesis the calculation would lead to the following Eq. (20):

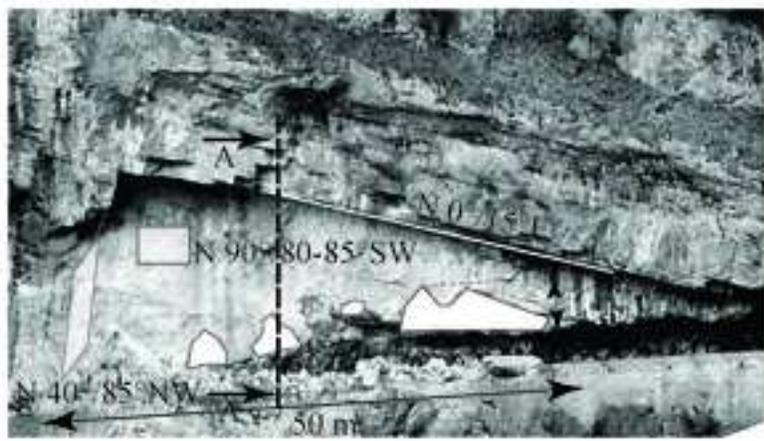
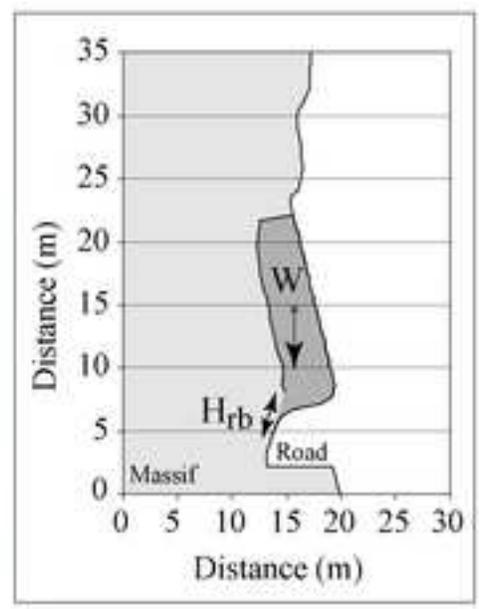
Figure 10

Fig. 10. (A) view of the scar of the Ranc rock fall, with the rock bridges in white and (B) cross-section A-A of the cliff before failure with the position of the equivalent rock bridge.  $W$ : weight of the unstable block ;  $H_{rb}$ : height of the equivalent rock bridge.

The Ranc rock fall occurred on 30th January, 2004, 50 Km SW of Grenoble (Fig. 2). 2200 m<sup>3</sup> of rock collapsed onto the road, killing two people in a car. The cliff is 150 m in height, strikes N80 and dips 85-90° to the South. The fall occurred where the cliff formed an overhang due to the construction of the road 150 years ago (Fig. 10B). The limestone beds strike N0°, dip 15° to the East, and they are cut perpendicularly by 2 joint sets N100°/90° (J1) and N33°/75°SE (J2). The scar is 50 m wide, about 20 m high and the mean thickness of the fallen mass was approximately 2.5 m. The failure surface is made up of a bedding plane N0°/15°E and two planes, N90°/80-85°S and N40°/85°NW belonging respectively to the joint sets (J1) and (J2) (Fig. 10A). In the major part of the scar, the rock is coated by a calcite crust (yellowish-orange colour). Intact rock fracture surfaces have been observed in the lower part of the plane N90°/80-85°S (Fig. 10). These fresh fracture surfaces, which cover an estimated area of 52 m<sup>2</sup> (5% of the whole scar area), are due to the failure of rock bridges. The equivalent rock bridge considered in the analysis has a height of 3.5 m and a width of 35 m. We obtained tensile strength and cohesion values equal to 3.2 MPa and 10.5 MPa respectively.

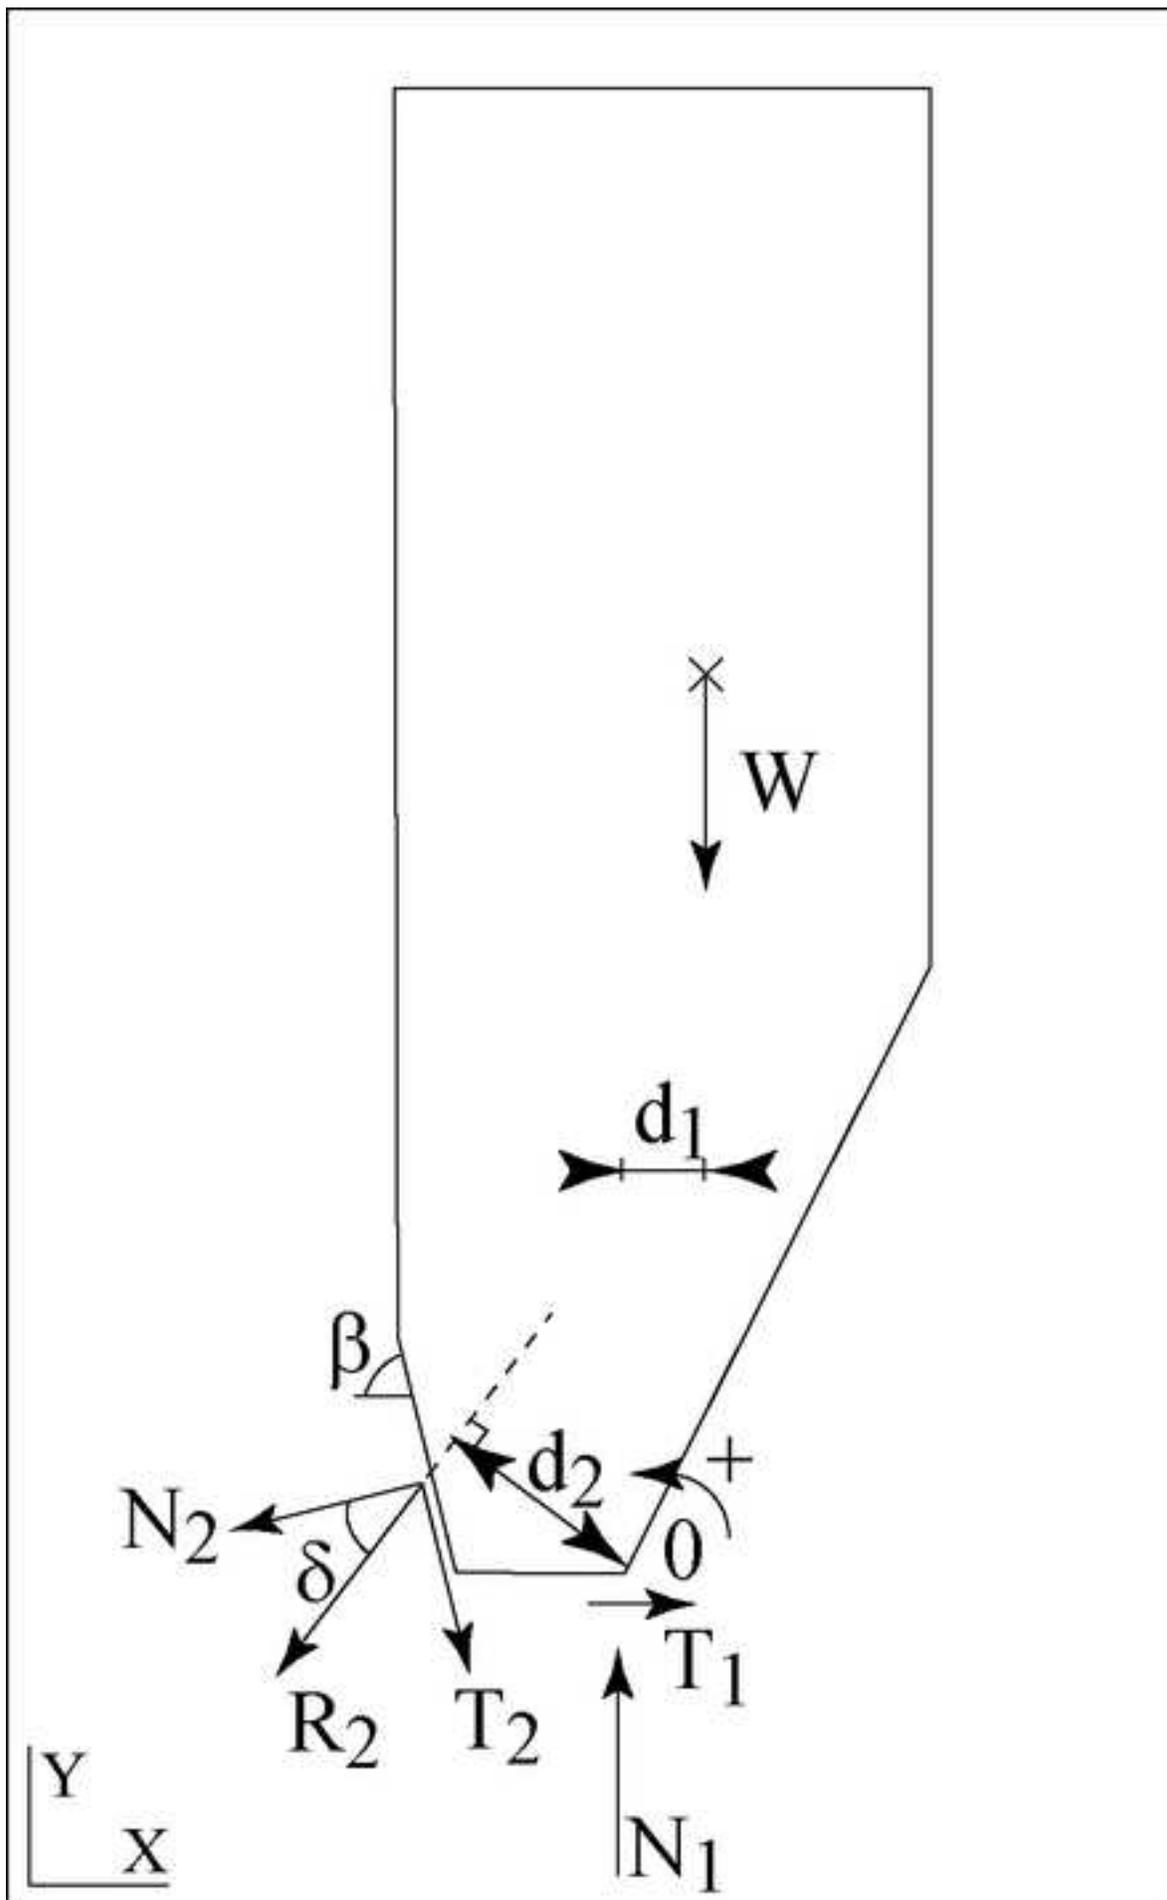
Figure11  
[Click here to download high resolution image](#)

Figure 11 shows the equilibrium conditions of forces and moments described by equations (22 - 24):

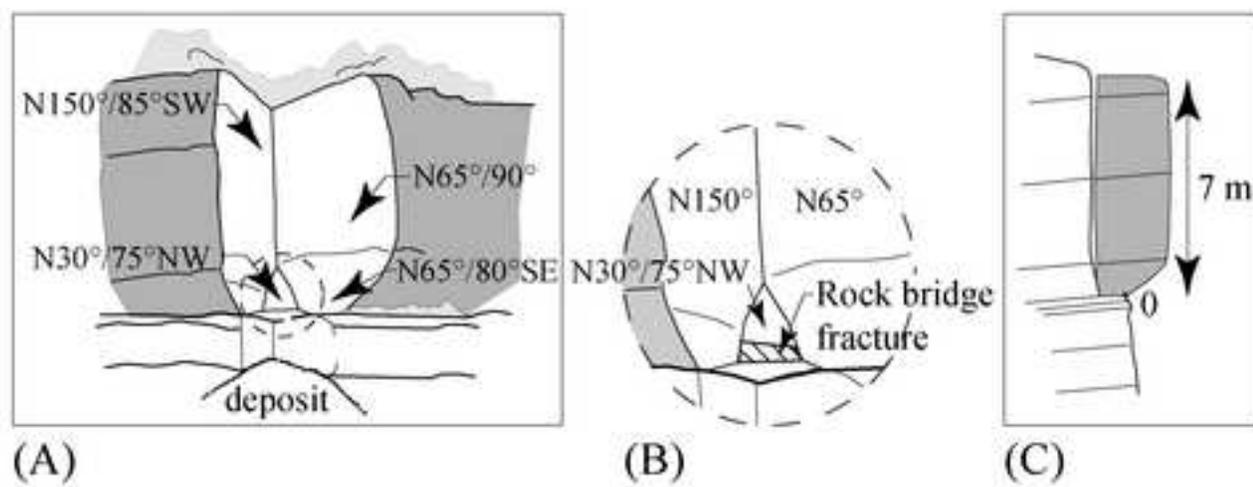
Figure 13

Fig. 13. (A) Sketch of the scar of the Goule Blanche rock fall, (B) focus on the zone of the intact rock fracture and (C) cross-section of the cliff before failure

The Goule Blanche rock fall, with a volume of about 30 m<sup>3</sup>, occurred in the upper part of a 200 m high cliff, striking N30°, at an unknown date around the year 2000. Beds are horizontal and cut by two steeply dipping joint sets which strike N64° (J1) and N152° (J2). The failure surface is about 7 m high. It is made up first by a wedge defined by two surfaces N65°/80-90°SE and N150°/85-90°SW belonging respectively to sets J1 and J2 (Fig. 13A). These two surfaces are coated with a calcite crust. In the lower part of this wedge, there is a singular plane N30°/75°NW, which includes a fresh intact rock fracture surface (Fig. 13B). This fracture surface has an area of 0.2 m<sup>2</sup> (0.8 % of the scar area). The base of the block is made up of a horizontal bedding plane. The lower part of the fallen mass was overhanging, allowing for a toppling mechanism (Fig. 13C). According to the maximum work principle, the stress in the rock bridge was a pure shear stress (Fig. 12). With a friction angle of 30° for the base of the block, the failure criterion (Eq. 9) is fulfilled. The estimated in situ cohesion and tensile strength values are respectively 14 MPa and 4.2 MPa.
